Manhole Inspection Summary

Manhole # S27O1_009MH

Insp Date: **3/10/08 10:03 AM**

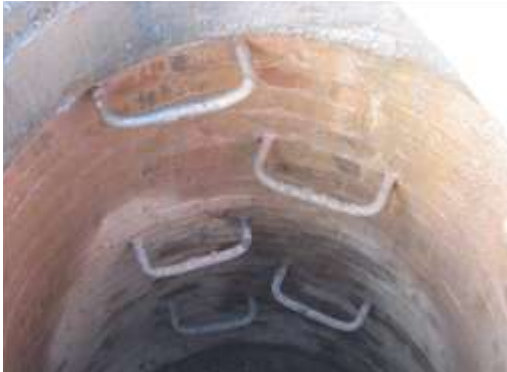
Steps Count: **5** Missing: **0** ☐ Corroded

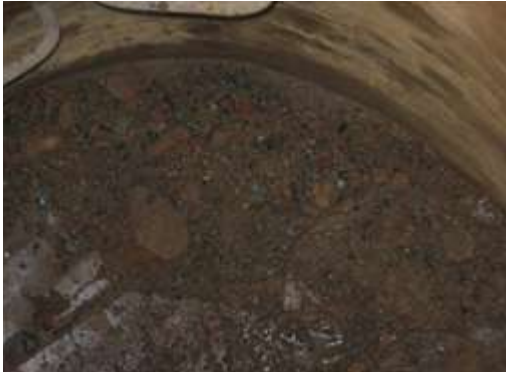
Defect 1

Debris

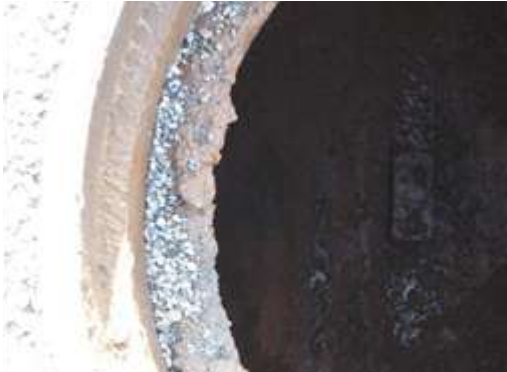
Defect 2

Frame Offset: **2** (in.) Condition: ☒ Sound ☐ Cracked ☐ Leaks

Frame offset

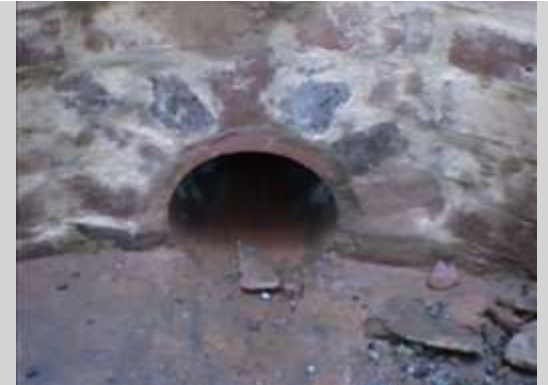
12 O'Clock Outflow

8 in. Circular Gravity Sewer
Pipe Out @ 12 O'Clock

Infiltration: **None** Pipe Seal Cond: **Sound**
